# STM32F40x and STM32F41x Errata sheet

## STM32F405/407xx and STM32F415/417xx device limitations

This errata sheet applies to the revision A and Z of STMicroelectronics STM32F405xx/STM32F407xx and STM32F415xx/STM32F417xx microcontroller families. In this document, they will be referred to as STM32F40x and STM32F41x, respectively, unless otherwise specified.

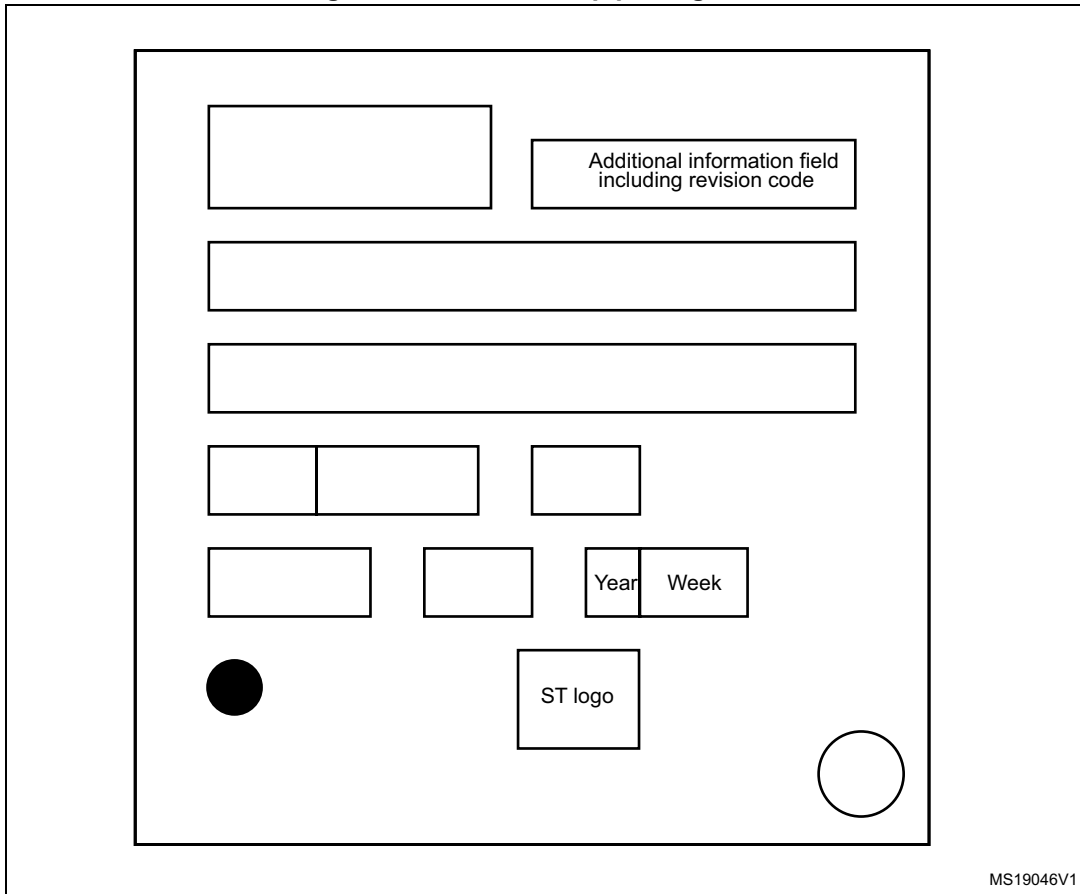
Figure 1. UFBGA176 top package view

Figure 1, Figure 2, Figure 3, Figure 4, Figure 5 and xxxx show the marking compositions for the UFBGA176, LQFP176, LQFP144, LQFP100, LQFP64 and WLCSP90 packages, respectively. The only fields shown are the Additional field containing the revision code and the Year and Week fields making up the date code.

1. The REV\_ID bits in the DBGMCU\_IDCODE register show the revision code of the device (see the STM32F40x and STM32F41x reference manual for details on how to find the revision code).
2. Refer to [Appendix A: Revision code on device marking](#) for details on how to identify the revision code and the date code on the different packages.
